# Carnation

## Wastewater Treatment Plant Appendix D - River Discharge Technical Information

**WASTEWATER TREATMENT PLANT OUTFALL STUDY**

**TECHNICAL MEMORANDUM 12 – OUTFALL EVALUATION**

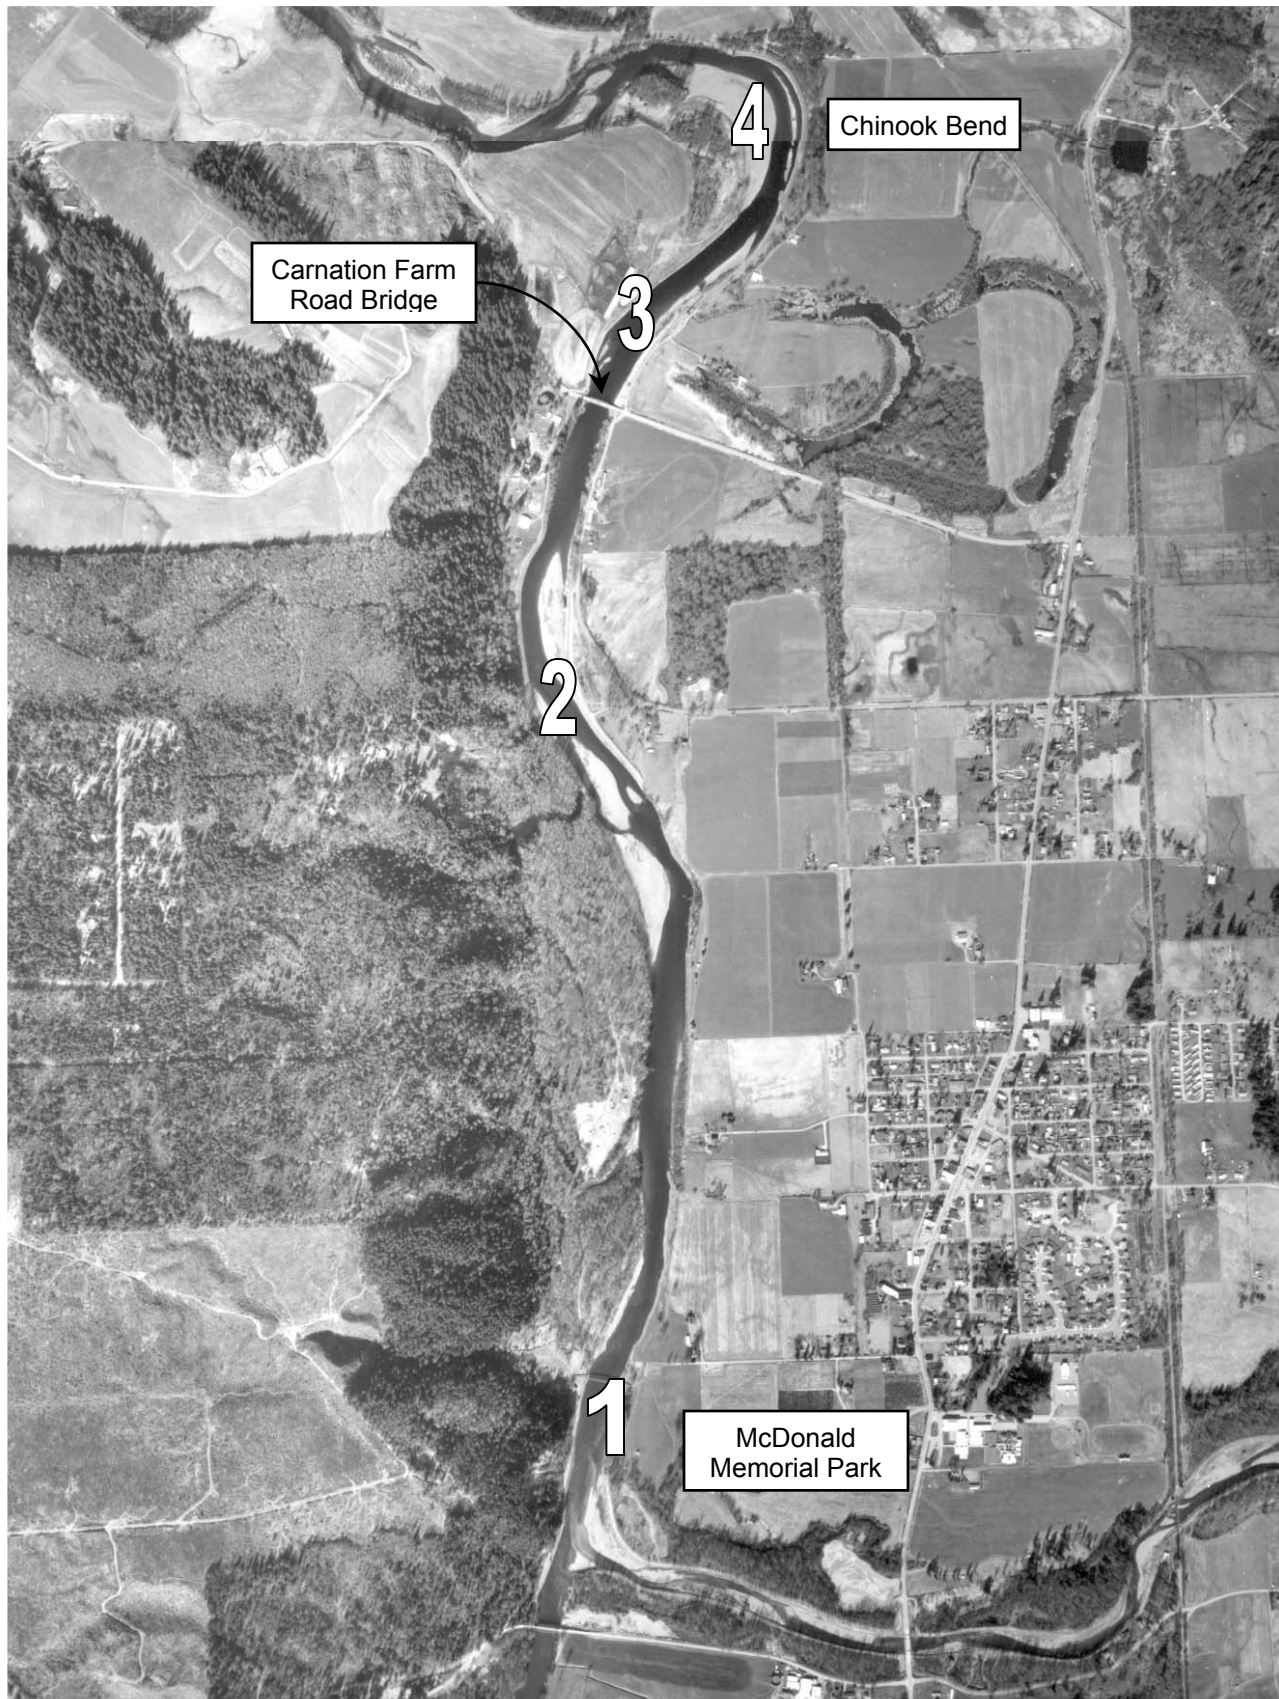
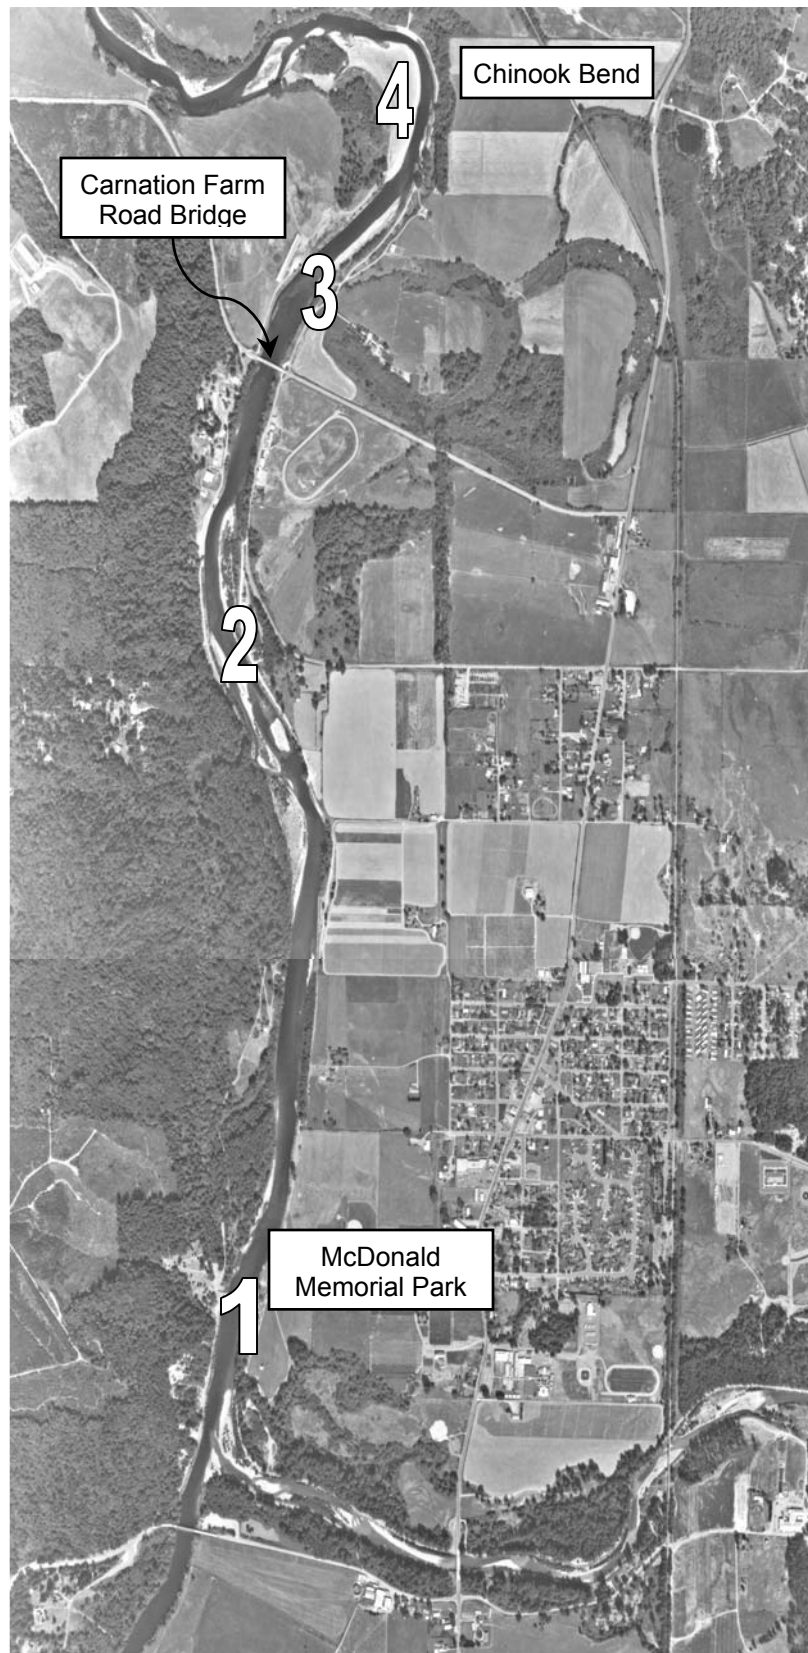
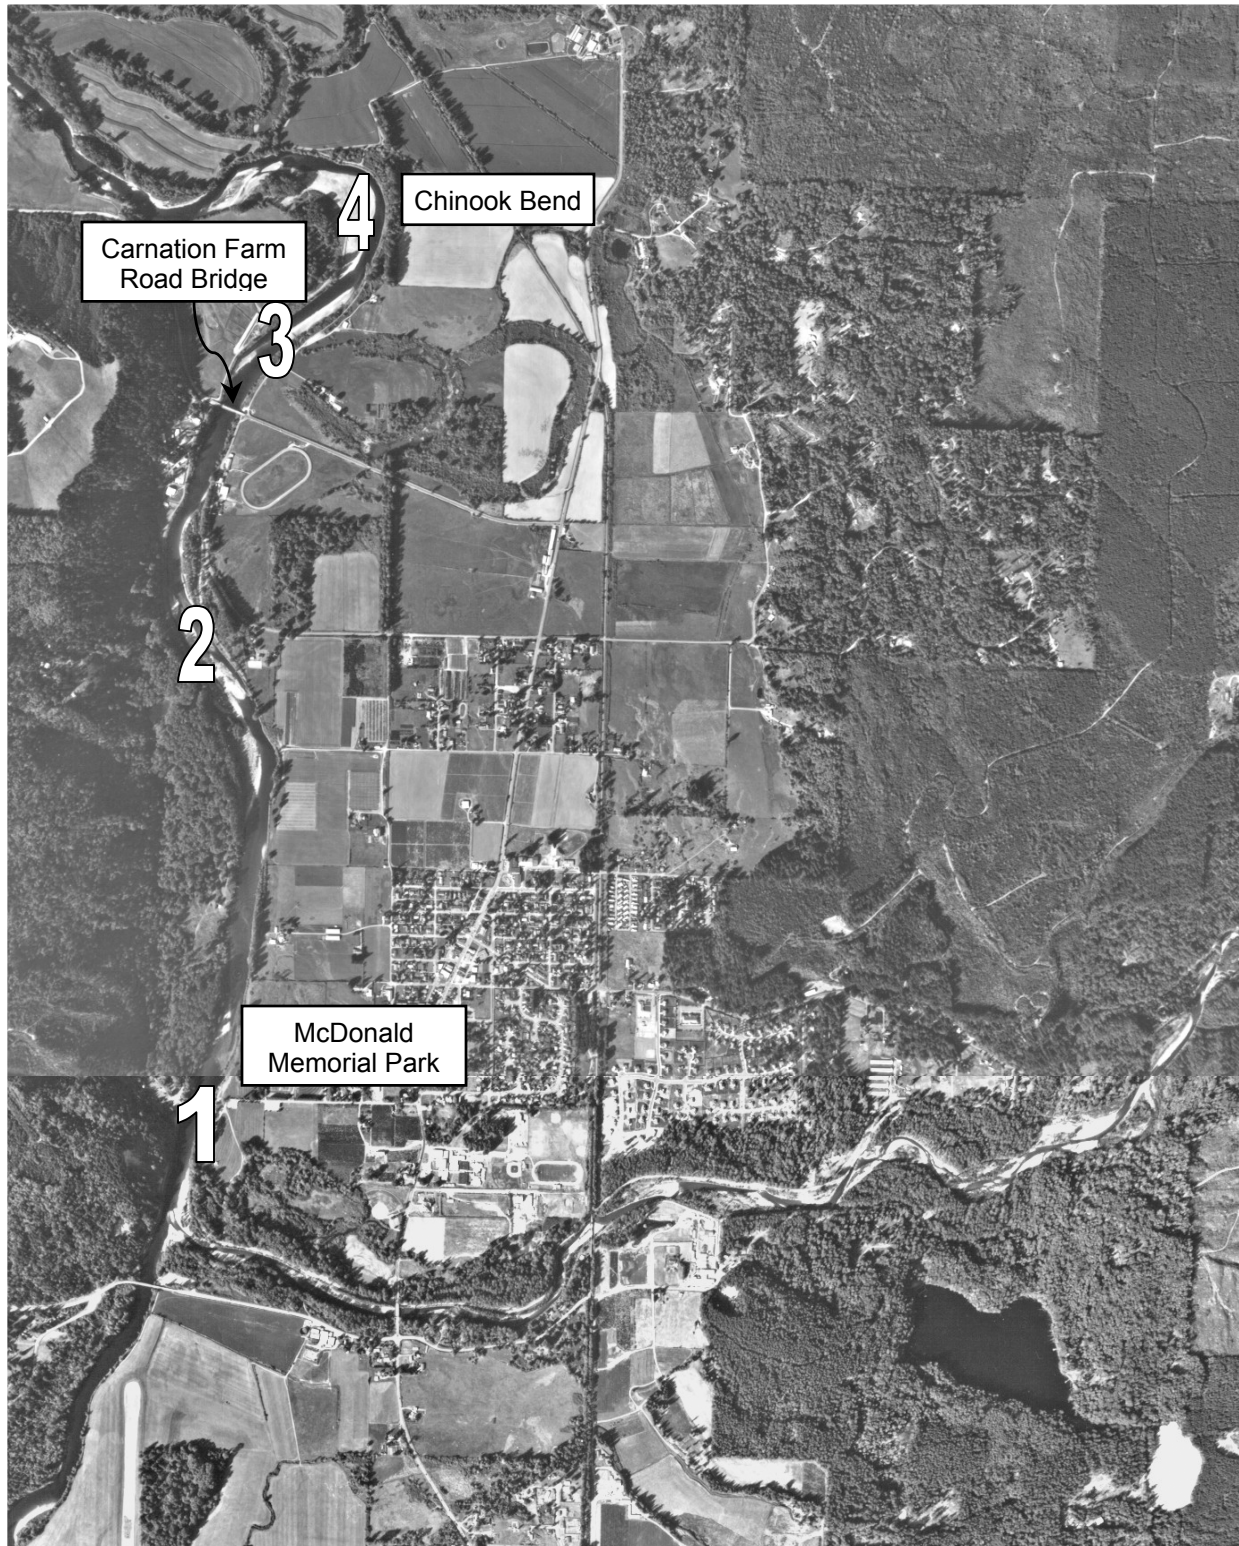
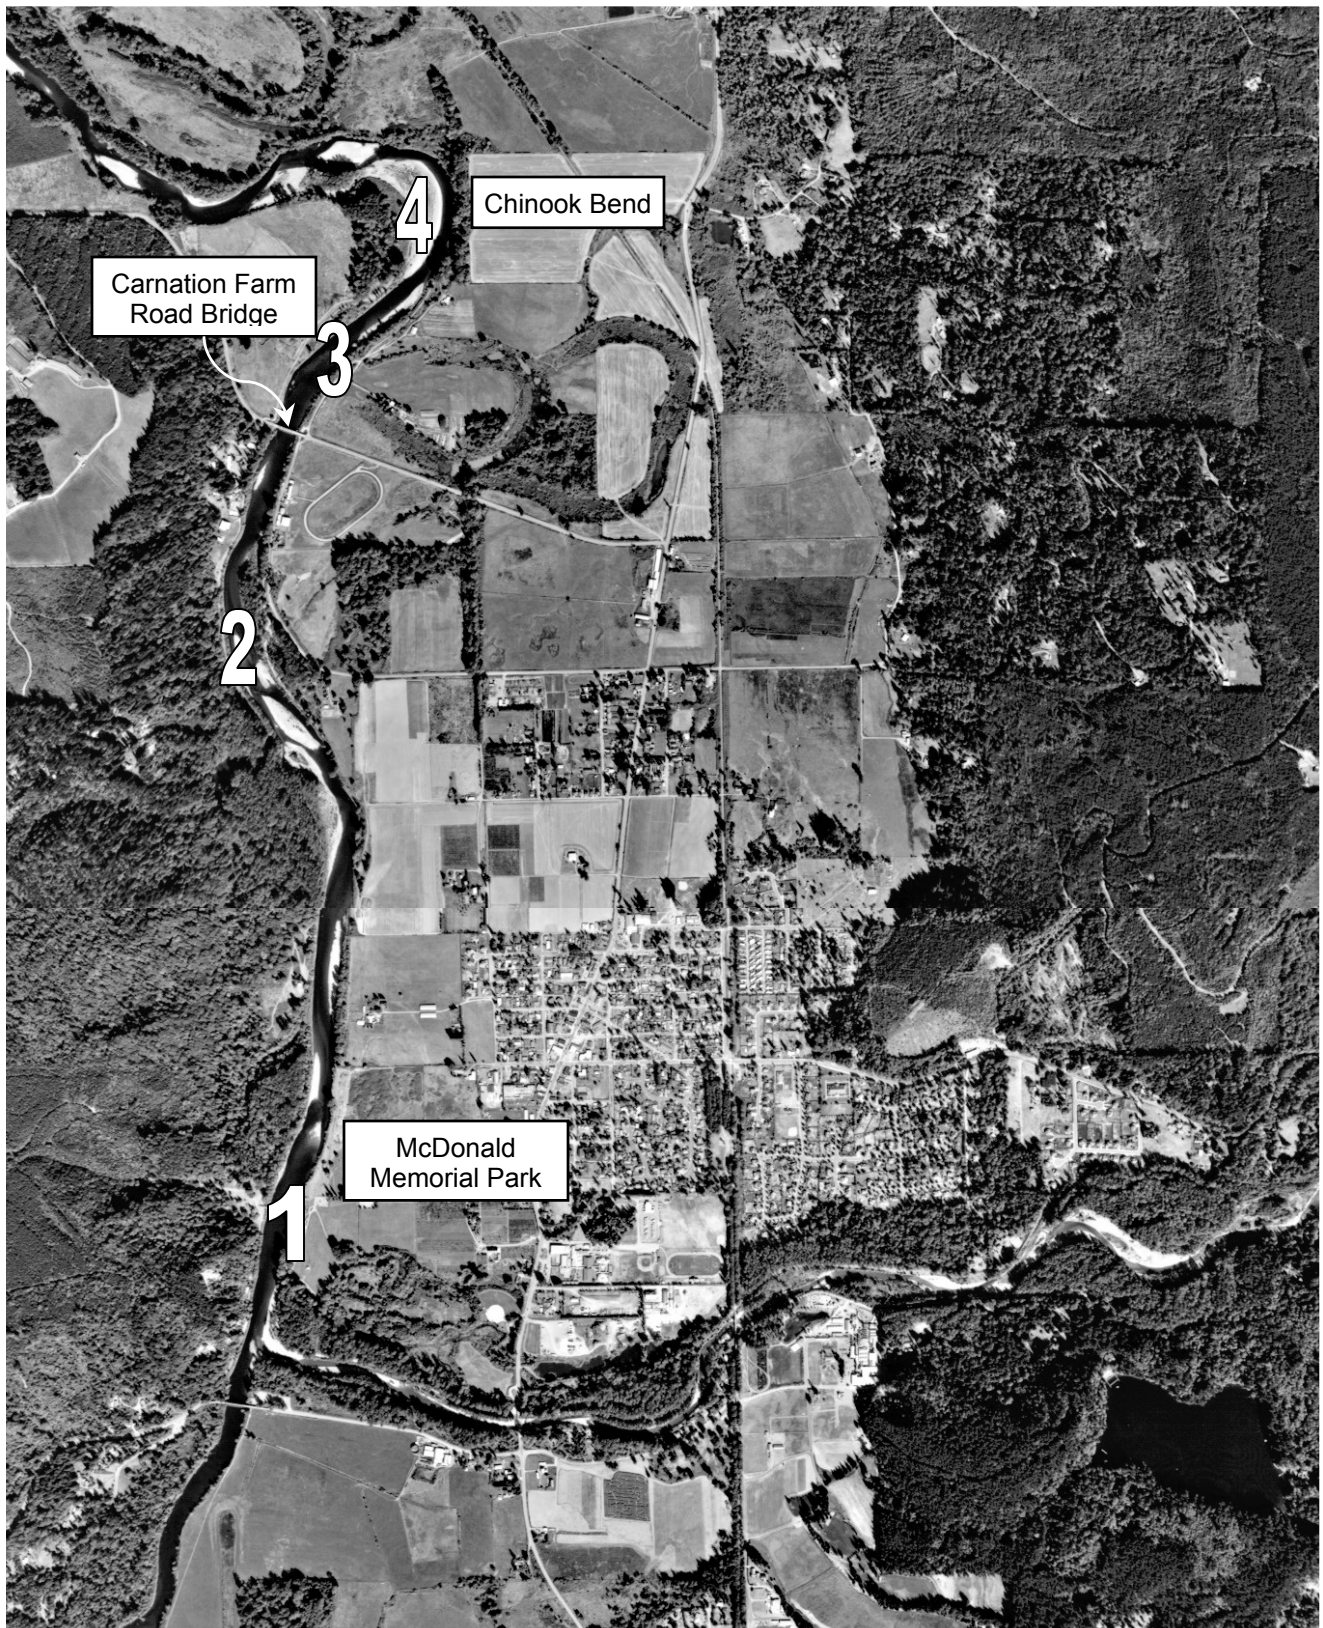
Figures 1, 2, 3, and 4 are aerial photographs, spanning the years 1985 through 2002, of the reach of the Snoqualmie River being evaluated for possible outfall locations. In addition to these photographs, aerial photographs for years prior to 1985 and as far back as the year 1938 were also examined. The purpose of this review is to assess the historical channel stability in various reaches.

Several areas of the Snoqualmie River in the vicinity of Carnation will not support an outfall. These areas are identified in the aerial photographs by gravel bars and stream channels that have changed over time. Areas deemed unsuitable for siting an outfall are identified numerically on the aerial maps (Figures 1 through 4) and delineated on the location map (Figure 5). Descriptions of the unsuitable areas follow:

1. Upstream of McDonald Memorial Park, the right bank has irregular and shifting gravel bars that would damage and/or periodically bury an outfall discharge.
2. Gravel bars, an unsuitable condition for an outfall location, have formed on the right bank approximately one-half of the way between McDonald Memorial Park to Chinook Bend
3. The reach upstream of the Carnation Farm Road Bridge has had numerous transient gravel bar formations
4. The left bank, or inside bend, of Chinook Bend consists of a significant gravel bar

The earlier photographs show a gravel bar near the right bank of Chinook Bend. Aerial photographs from 1980 show this bar eroding and the main channel shifting towards the outside of the bend. Photographs taken after 1990 show no evidence of this bar and the main channel has shifted to the outside of the bend. This area has remained stable since the 1990 photographs and will be considered for one of the outfall locations.

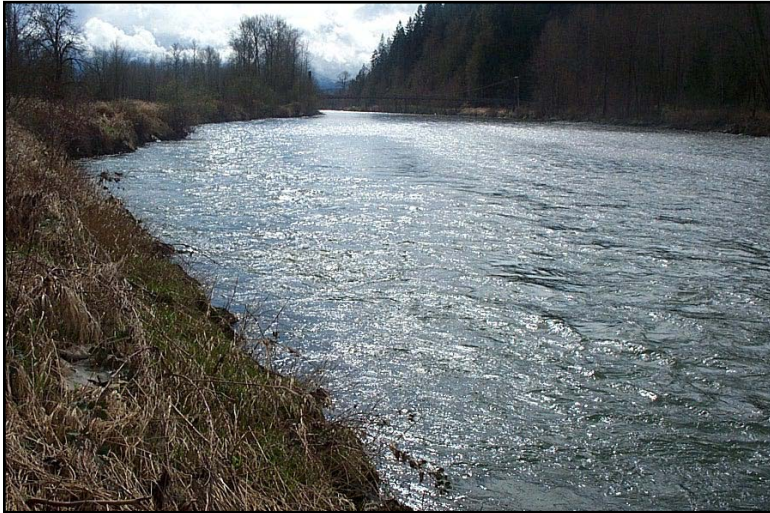
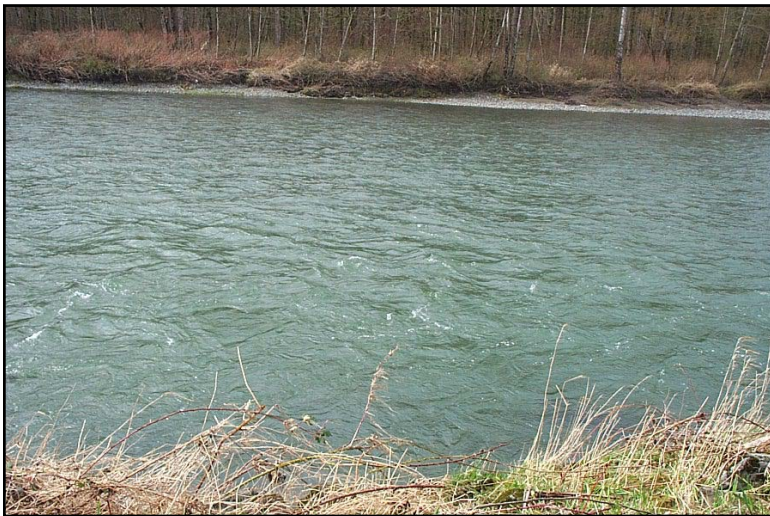
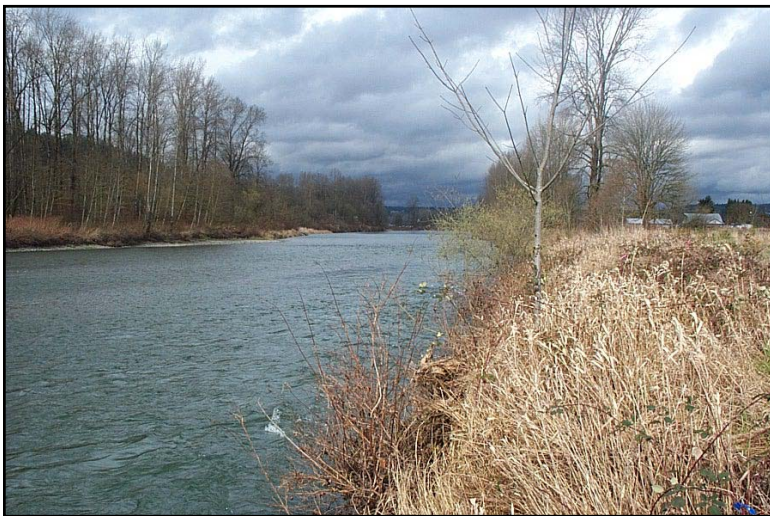
**Figure 6: Snoqualmie River Near McDonald Memorial Park**

Carnation owns a parcel of land near McDonald Memorial Park that is being considered as one of the potential sites for the WWTP. The parcel is located a few hundred feet east of the Snoqualmie River. The river in this area, near River Mile (RM) 24, has a wide bed with a steep, riprapped right bank. The left side of the river in this area is gravelly with some cobbles and sandy banks. The photographs in Figure 6, and the photographs of the other locations, were taken on March 20, 2003. At the time the photographs were taken, the river flow rate was approximately 3400 cubic feet per second (cfs).

The river in the vicinity of McDonald Memorial Park has a slight bend and a deeper channel at the right. A review of historical aerial photographs indicates this area of the river has been stable with no braiding or main channel movement. If an outfall was located in this area or any of the other considered river sites, the discharge pipe, either open-ended or with a diffuser, would probably be anchored at the toe of the bank and extend 10 to 20 feet into the channel at an approximate 45-degree downstream angle.

*View upstream*

*View across river*

*View downstream*

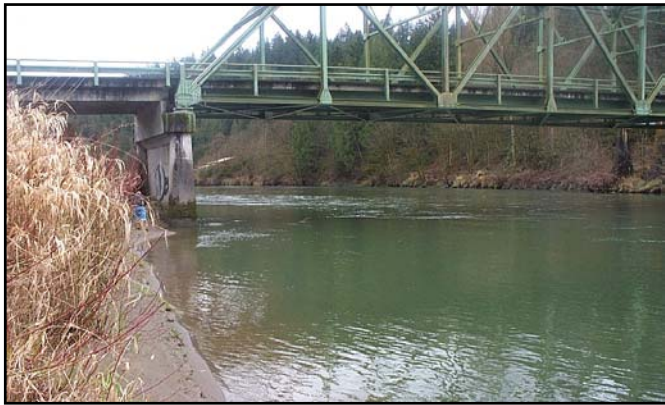
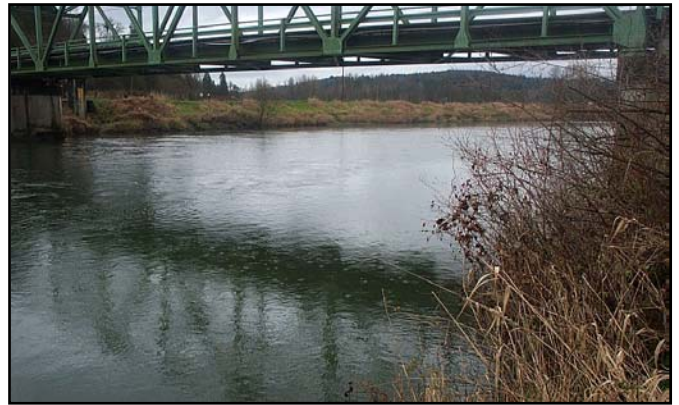
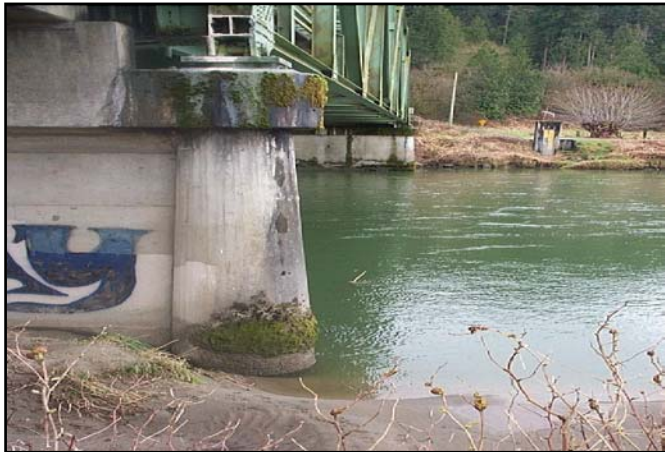
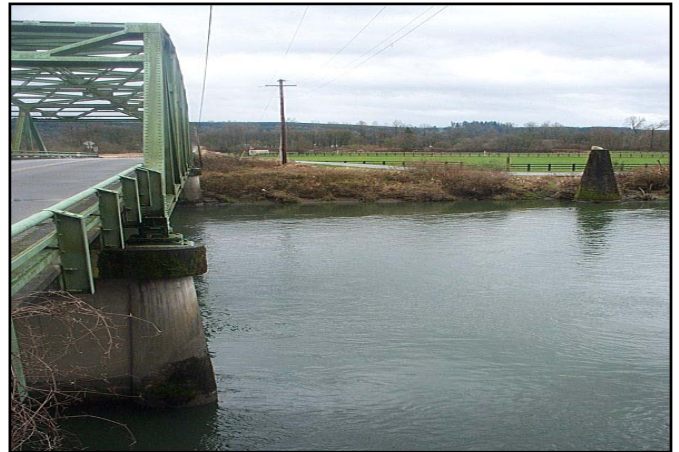
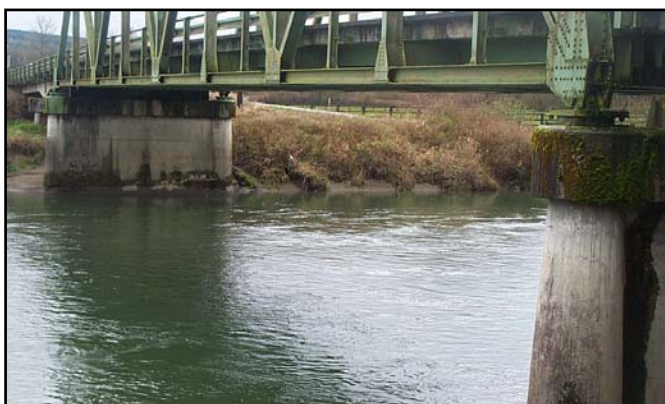
**Figure 7: Snoqualmie River at Carnation Farm Road Bridge**

The Carnation Farm Road Bridge is located between RM 22 and 23. The river is fairly wide, and based on observations and historical aerial photographs, the flow is dispersed throughout the entire river width. Significant features of this location include footings and piers of the Carnation Farm Road Bridge near both banks. The remnants of a previous bridge, four concrete footings and piers, remain in the river slightly upstream of the existing bridge. One of the piers on the east bank has toppled into the river. Also at this location, the United States Geologic Survey (USGS) operates a gaging station, No. 12149000, located on the river's west bank. Figure 7 depicts this area.

*View north of bridge on east bank*

*View south of bridge on east bank*

*View north side of bridge on east bank*

*View south side of bridge on west bank,  
old bridge pier on right side*

*View north side of bridge on west bank*

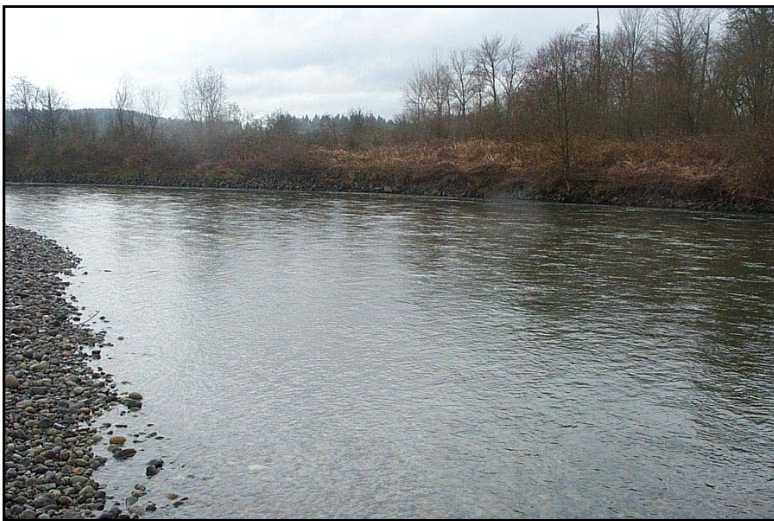
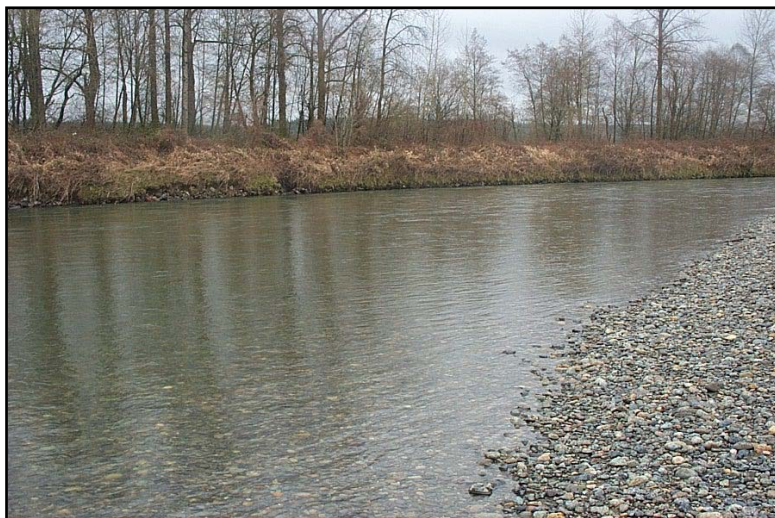
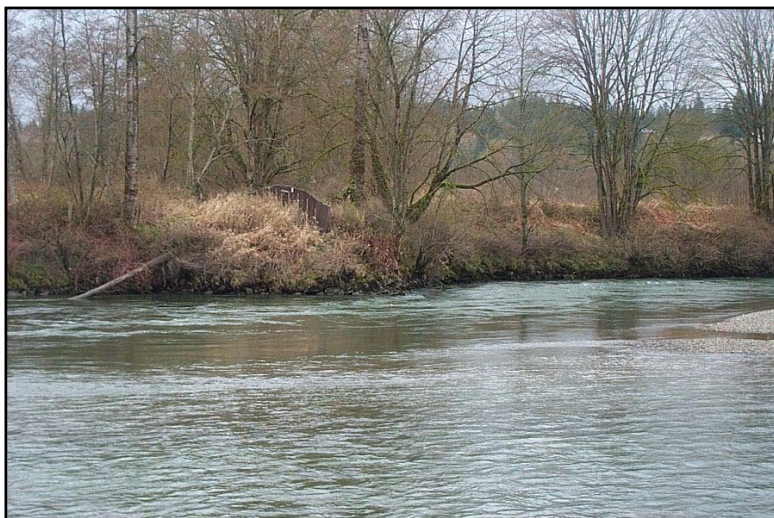
**Figure 8: Snoqualmie River at Chinook Bend**

Chinook Bend, slightly downstream of RM 22, forms a 90-degree bend where the river flow direction changes from north to west (Figure 8). The right bank is riprapped, which helps to stabilize the bank and channel location. Outside bends in rivers are desirable locations for outfall structures because these areas are typically stable and have deeper channels than other areas of the river. Several suitable outfall sites exist on the right bank of the river along this reach.

*View downstream from west shoreline at mid-bend*

*View upstream from west shoreline at mid-bend*

*View across river from west shoreline at downstream end of bend*
